In 2018, the Town retained Pinchin to conduct a hazardous materials assessment of the Dr. Duncan Murray Recreation Centre located at 805 Switzer Drive, Hinton, AB. The assessment identified and evaluated the following materials: asbestos, lead, mercury, polychlorinated biphenyls (PCBs) and mould-contaminated materials. The following two (2) tables detail the location, drawing room number (attached), asbestos material/content and/or lead paint identified and its condition. Some of those materials presumed to be asbestos were sampled and confirmed to be asbestos or non-asbestos. The materials sampled have comments made in the tables below.

CLIENT: <b>TOWN OF HINTON</b>	
LOCATION: <b>HINTON RECREATION CENTRE 805 SWITZER DRIVE, HINTON, AB</b>	
TITLE: <b>HAZARDOUS BUILDING MATERIALS ASSESSMENT MAIN FLOOR</b>	
DATE: 04/16/2018	PROJECT #: 220419.000
DRAWN BY: EK	DRAWING:  <b>1 OF 2</b>
CHECKED BY: LF	
SCALE: NTS

HAZARDOUS BUILDING  
MATERIALS ASSESSMENT  
SECOND FLOOR

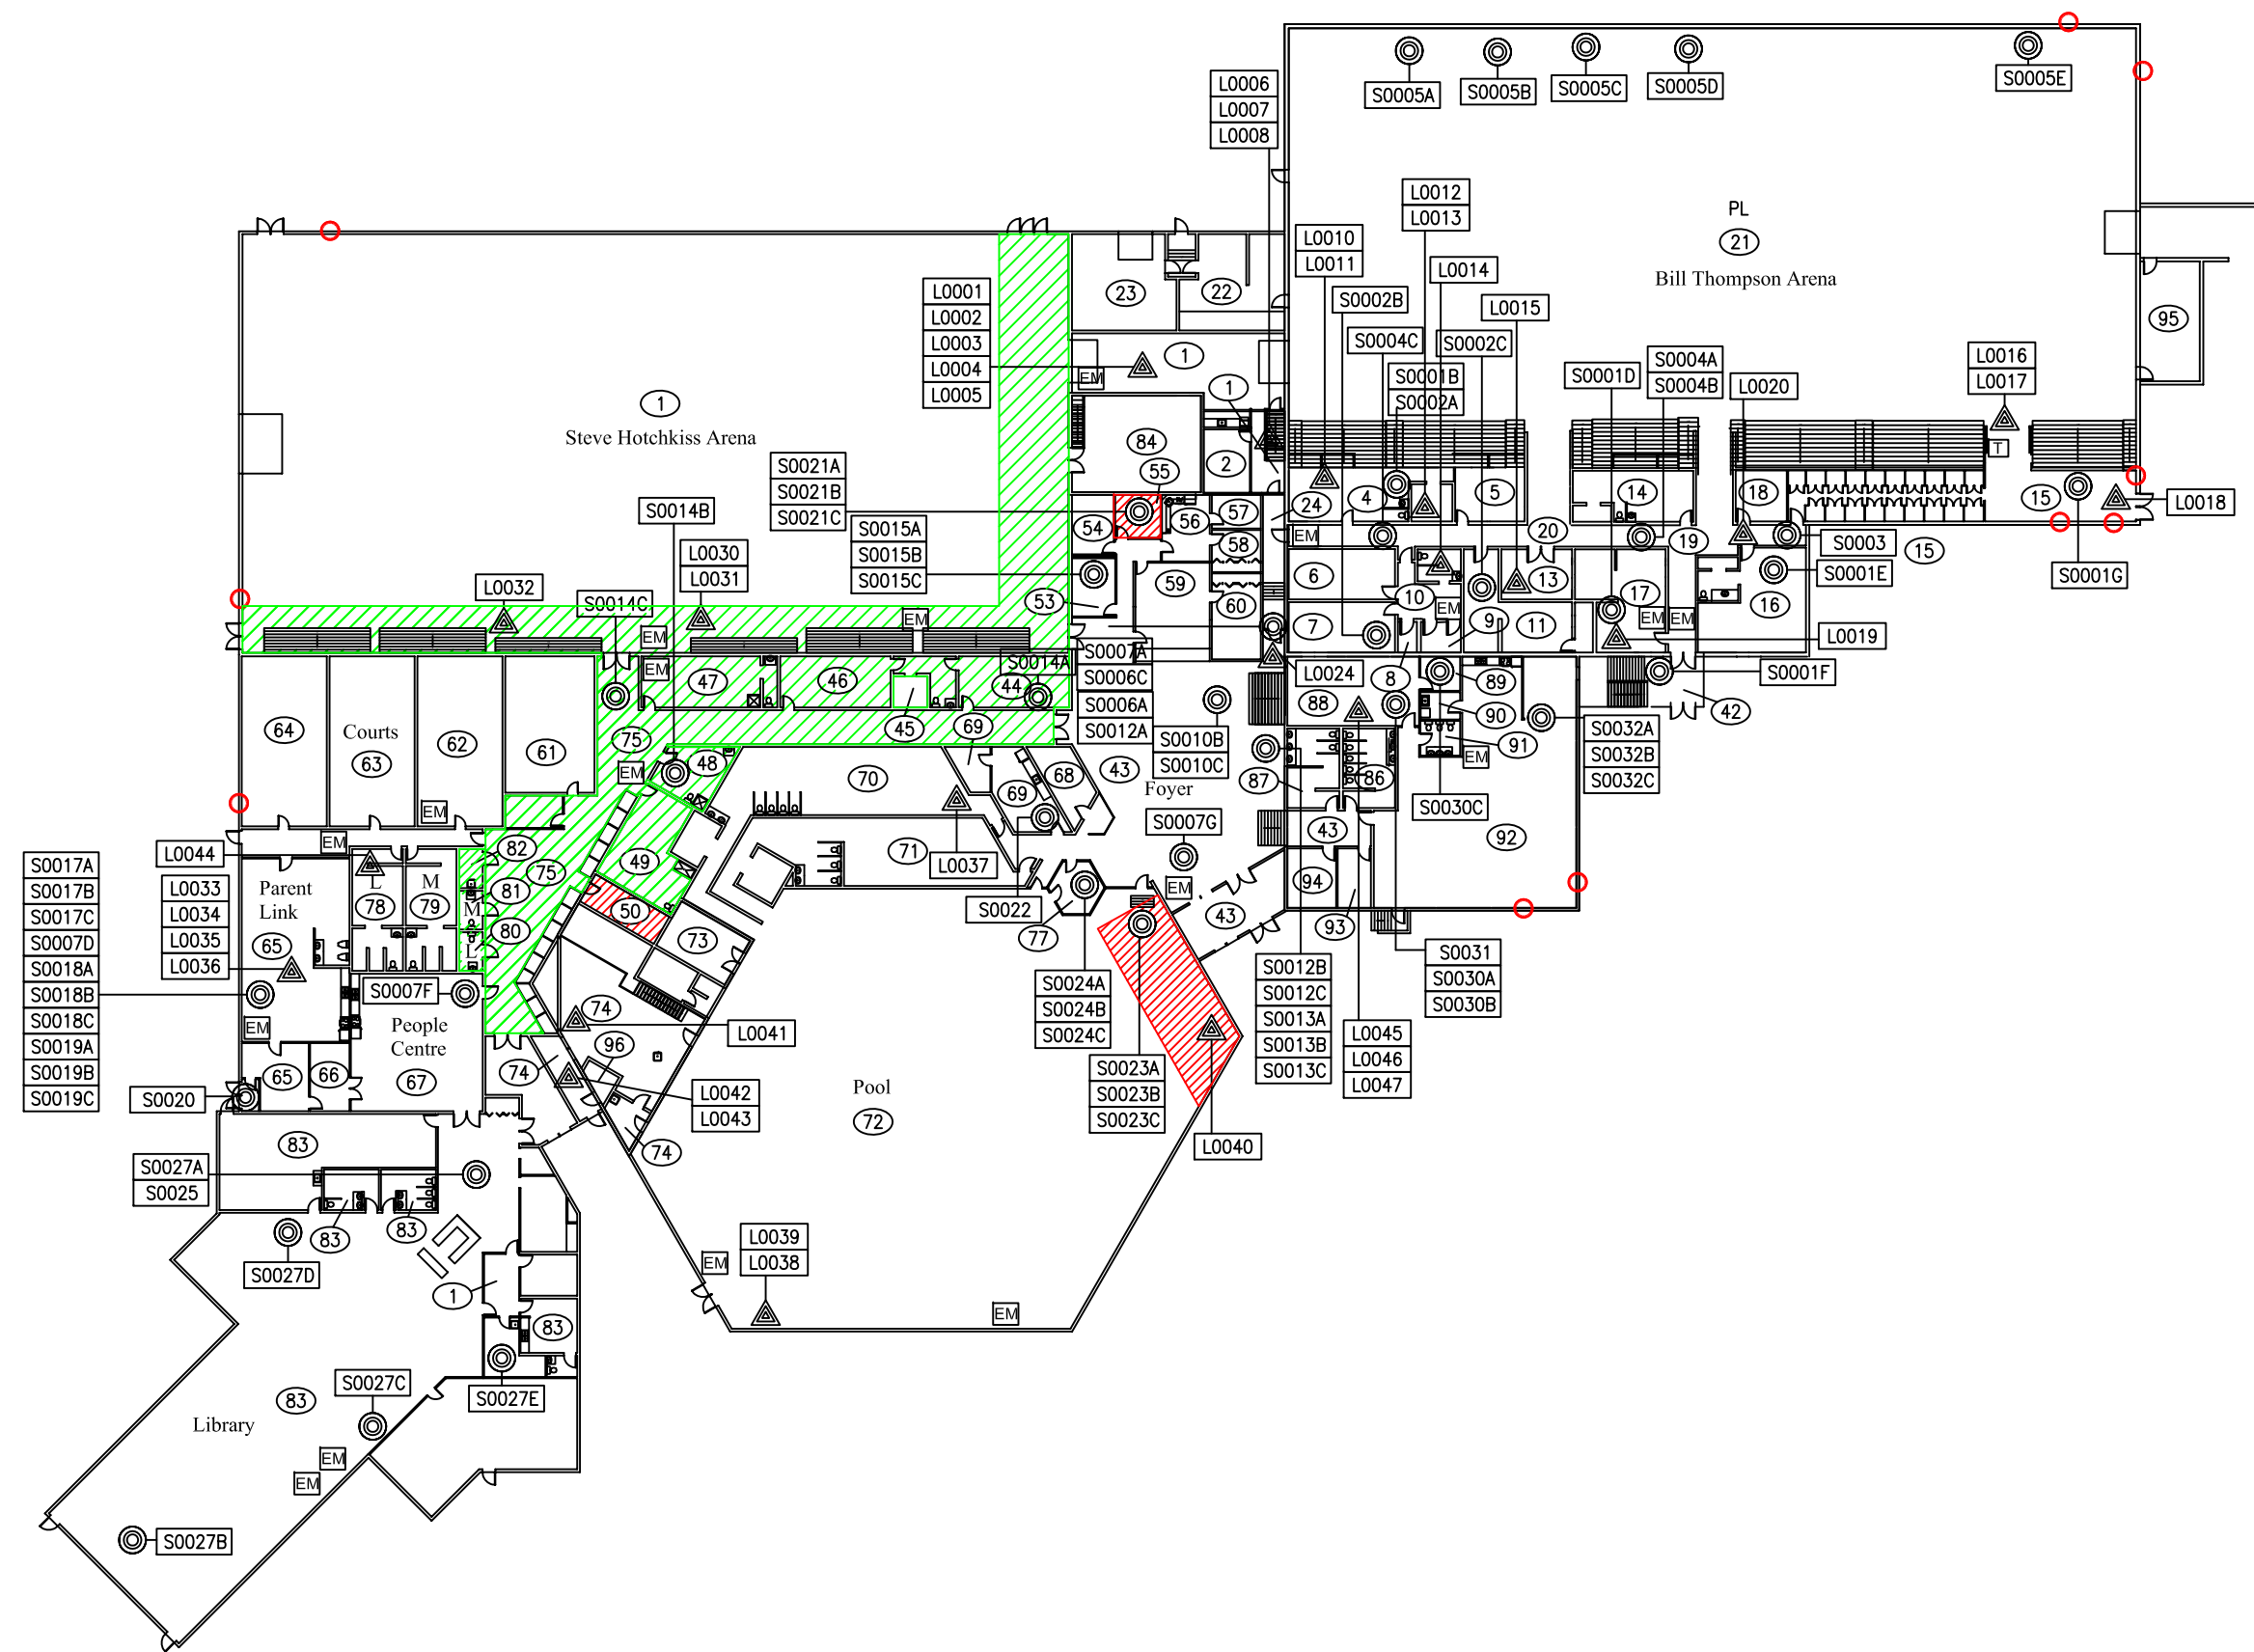
Location	Room Number on Drawing	Asbestos Containing Materials (ACM)	Asbestos Type (%) in 2018 Report	Condition/Comment
Exterior Block Walls	n/a	Loose fill vermiculite block wall insulation	1-5% Libby Amphibole	BTA exterior walls were encapsulated with paint and cracks were sealed with caulking. All residual ACM was removed from surfaces.
Bill Thompson Arena (BTA)	Location 21	Plaster on Walls	0.1-1% Chrysotile	Material was encapsulated with paint then covered with plywood in 2019 to prevent delamination.
Janitors Room, Office, Snack Bar	Locations 50, 55, and 68	12"x12" tan with brown and white streaks vinyl floor tiles	1-5% Chrysotile	Material managed in place. 2021 Annual assessment review observed material to be in good condition.
Pool	Location 72	12"x12" tan with white streaks vinyl floor tiles	1-5%	Material managed in place. 2021 Annual assessment review observed material to be in good condition.

Steve Hotchkiss Arena and Dressing Rooms	Locations 44, 45, 46, 47, 48, 49, 52, 61, 75, 80, and 81	Black rubber floor tiles	0.1-1% Chrysotile	Material managed in place. 2021 Annual assessment review observed material to be in good condition.

Pool	Location 72	Spray-on fireproofing present	Presumed asbestos	Sample collected and confirmed as non-asbestos.
Library	Location 83	Chocolate brown vinyl sheet flooring	Presumed asbestos	Sampled and confirmed as non-asbestos.
Office	Location 59	12"x12" pink with flecks vinyl floor tiles	Presumed asbestos	Material managed in place. 2021 Annual assessment review observed material to be in good condition.
Office	Location 59	12"x12" red with flecks vinyl floor tiles	Presumed asbestos	Material managed in place. 2021 Annual assessment review observed material to be in good condition.
Office	Location 59	12"x12" black with white flecks vinyl floor tiles	Presumed asbestos	Material managed in place. 2021 Annual assessment review observed material to be in good condition.

Location	Location/Room Number on Drawing	Lead Based Paint	Comments
Shop and Bill Thompson Arena	Locations 1 and 21	Green poured concrete wall	In 2019, delaminating paint was removed and encapsulated with new paint.
Shop	Location 1	Light blue/grey wood wall	2021 Annual assessment review observed paint in condition.
Mechanical Room	Location 13	Grey block wall	Material managed in place. 2021 Annual assessment review observed material to be in good condition.
Storage, Mechanical room, Ammonia room, Youth centre, Mechanical room, Maintenance office	Locations 15, 22, 23, 31, 74, and 84	Mustard yellow block wall	2021 Annual assessment review observed paint in good condition.
Bill Thompson Arena	Location 21	Grey wood bleachers	The bleachers have been re-painted. 2021 Annual assessment

review observed paint in good condition.
Bill Thompson Arena	Location 21	Red wood bleachers	The bleachers have been re-painted. 2021 Annual assessment review observed paint in good condition.
Youth Centre	Location 31	Crimson red block wall	2021 Annual assessment review observed paint in good condition.
Youth Centre	Location 31	Yellow drywall wall	2021 Annual assessment review observed paint in good condition.
Steve Hotchkiss Arena, First Aid room, Lifeguard office	Locations 52, 69, and 77	Dark blue block wall	2021 Annual assessment review observed paint in good condition.
Steve Hotchkiss Arena	Location 52	Dark blue wood bleachers	2021 Annual assessment review observed paint in good condition.
Steve Hotchkiss Arena	Location 52	Light blue wood bleachers	2021 Annual assessment review observed paint in good condition.
Old Parent Link, Office, Playschool Office, Laundry, Washroom, Playschool	Locations 65, 66, 88, 89, 90, 91, and 92	White metal door and trim	2021 Annual assessment review observed paint in good condition.

Mechanical room	Location 74	Red structural steel	2021 Annual assessment review observed paint in good condition.
Mechanical room, Maintenance office, Mechanical office	Locations 74, 84, and 85	Chocolate brown metal doors	2021 Annual assessment review observed paint in good condition.
Janitors room, Woman's Washroom, Men's Washroom, Laundry	Locations 50, 78, 79, and 82	Light yellow block wall	2021 Annual assessment review observed paint in good condition.
Playschool office, Washroom, Playschool	Locations 88, 91, and 92	Periwinkle blue drywall	Some of these areas have been painted with a new color. 2021 Annual assessment review observed paint in good condition.
Playschool Office, Storage, Laundry, Playschool	Locations 88, 89, 90, and 92	Sunshine yellow drywall	Some of these areas have been painted with a new color. 2021 Annual assessment review observed paint in good condition.

The Town performed extensive work throughout the building in 2019 to rectify any material in poor condition. Any asbestos containing materials (ACM) or lead in poor condition were either enclosed, encapsulated or removed. Each year these materials are visually inspected by the Town for condition, see condition/comments for more information.
