## Beaver Boardwalk Pedestrian Bridge

**1. What is the height, weight and width of the structure?**

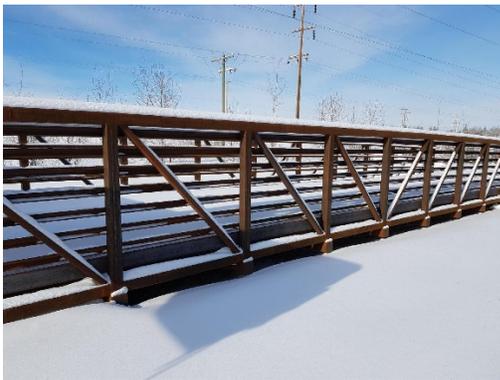
Please see the photo (below) of the actual bridge that will be installed. Grading and site landscaping are included in this project. Ongoing maintenance of the area will allow for the regrowth of vegetation once the project is complete. This may take a few growing seasons.

Bridge photo taken 02/07/2019 prior to installation

Bridge deck is timber slats. The support deck construction and side railings are constructed out of metal utilizing weathered steel which does not require paint (preservation maintenance).
